RAPPORTO DI COLLAUDO / TEST REPORT
Prova idraulica e Visivo & Dimensionale / Hydrostatic and Visual & Dimensional

Componente Component	DN Nominale Nominal Size	P di Prova (bar) Test Pressure (bar)	T di Prova (sec) Test Time (sec)	Note / Remarks
Fulg-o-strong	8"	1055	3027	Customer: Fulgosi S.r.l. Description: Fulg-o-strong 8" - Prototype PO No.: Burst Test

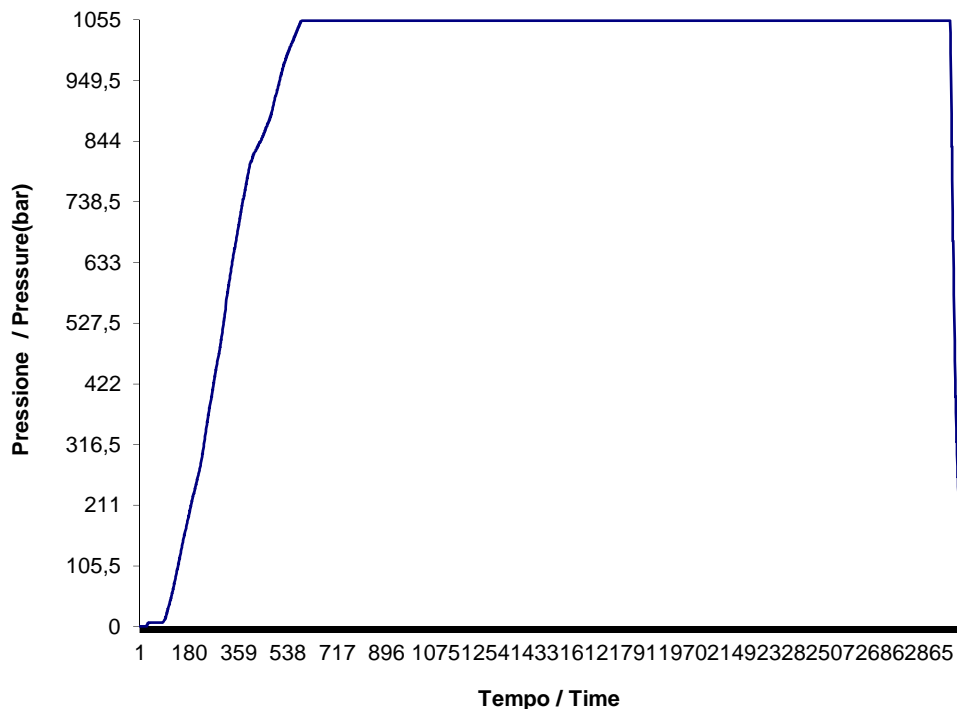
Andamento Pressione / Pressure Trend

Holding Time @ (P)		
Begin 11:00	End 11:40	Duration 40min.
Specifiche di riferimento References		
Procedure No.:	IO-03 rev.1	
Esito collaudo Test's result		
Hydraulic Test:	No leak nor deformation has been noticed	
Functional Test:	Open / Close cycle succesfully executed	
Costruttore Manufacturer	Cliente Customer	Notified Body
